# Greenham Common Walkover Survey

West Berkshire Council - 2016

Alex Godden - Archaeological Officer

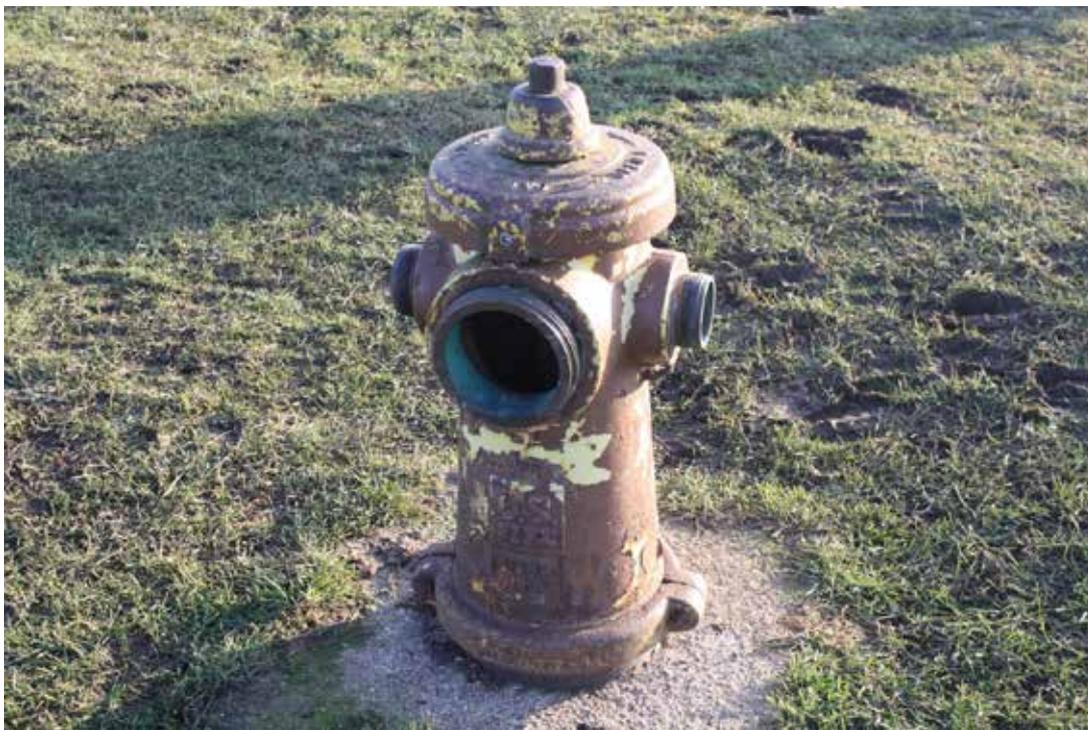
Fire Hydrant (HEMP Feature 155)

Iron fire hydrant with traces of cream and yellow paint (all three of the side caps are missing); standing to a height of 0.7 metres and set on a square concrete pad (c. 0.6 metres across). Has "VSP OPEN 5 1/4 VO" on the top; "655510 5 1/4 VO 10106 D1" on one side; "D1 US PIPE 1986 AWWA PAT. 4.123.285" on the other side above "TOPSIDE USP 668860" on the base.

Conservation potential: **MEDIUM**

This is the first of the hydrants visible on the path after turning right from the Control Tower. And is worth preserving and maintaining because of its high visibility. It will require specialist advice with a view to conserving to original character. Its position should be marked on route literature along with general information on fire hydrants.

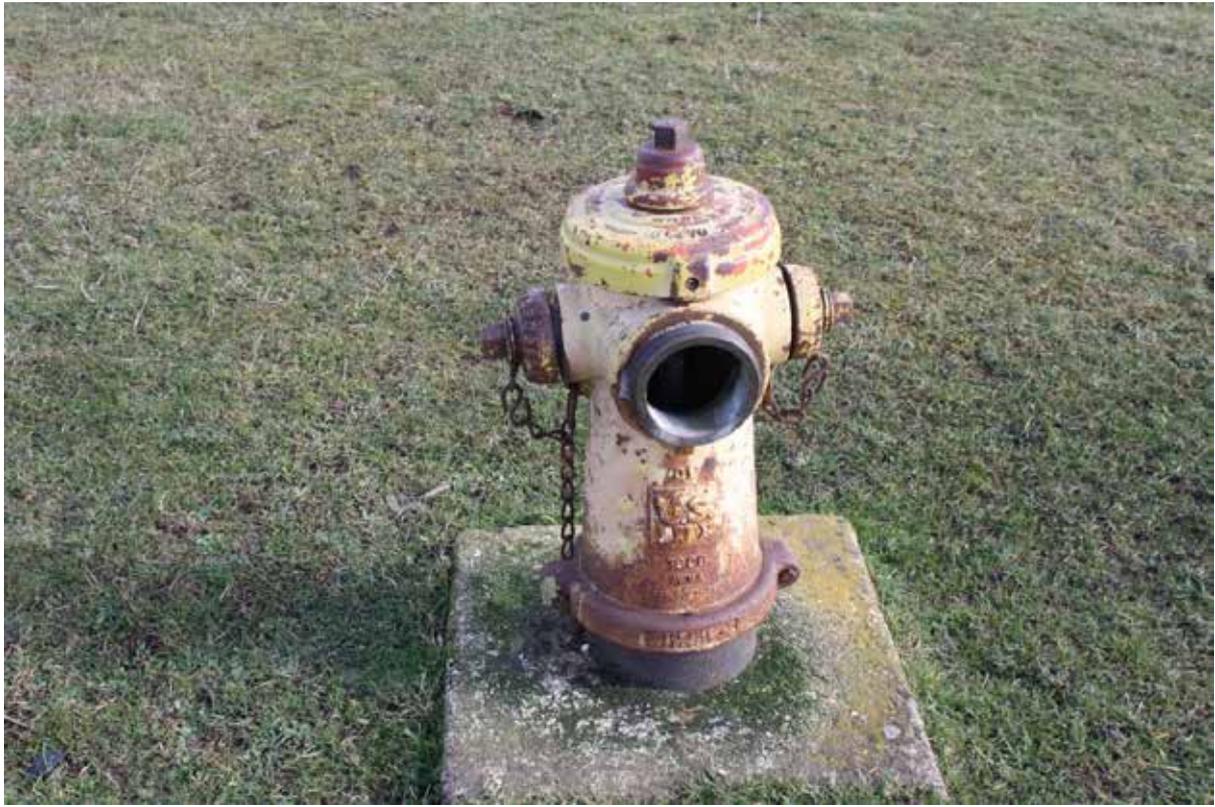
Fire Hydrant (HEMP Feature 157)

Iron fire hydrant painted cream with brown paint on the top and side caps, which have traces of red paint and have a yellow top coat (the front cap is missing); standing to a height of 0.7 metres and set on a square concrete pad (c. 0.6 metres across). Has "VSP OPEN 5 1/4 VO" on the top; "655510 5 1/4 VO 10106 D1" on one side; "D1 US PIPE 1986 AWWA PAT. 4.123.285" on the other side above "TOPSIDE USP 668860" on the base.

Conservation Potential: **HIGH**

Possibly worth preserving and maintaining because of its high visibility – it also retains the side caps. Will require specialist advice with a view to conserving to original character. Its position could be marked on route literature along with general information on fire hydrants.

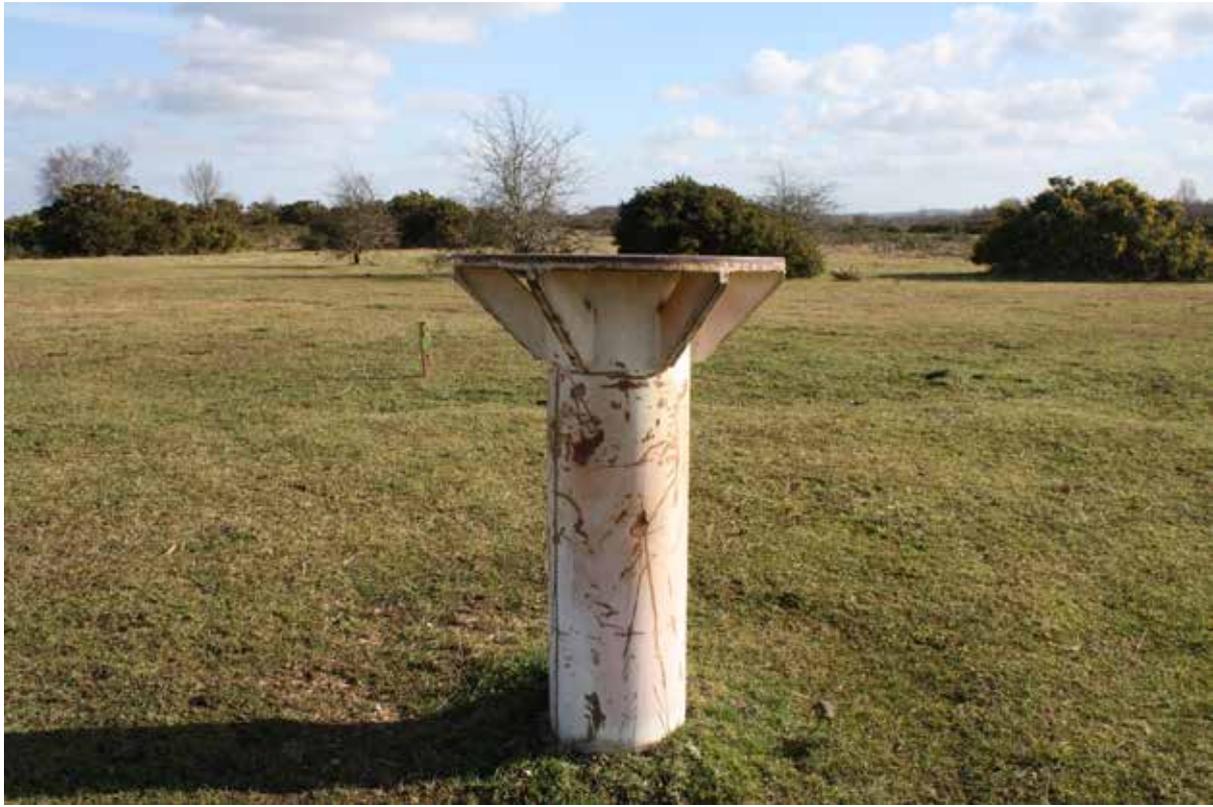
Possible Weather Station/Fire beater stand (HEMP Feature 227)

Originally described in HEMP document as 'Steel weather station painted white, standing to a height of 1.14 metres. The weather station is made from a pipe (with a diameter of 0.30 metres) set vertically in the ground and surmounted by a circular plate. The steel plate is 29mm. thick, 0.75 metres in diameter and has a central hole with a diameter of 0.18 metres'. Local knowledge has suggested that this interpretation is incorrect, and that this and similar structures were internal stanchions used to support the ceiling of underground fuel tanks, reused as fire-beater stands.

Conservation potential: **HIGH**

Any maintenance or repairs must be designed to maintain the original character of these structures as far as is possible, and should only be carried out following specialist advice.

This example has reasonable potential as clearly visible from trails – rather than an interpretation board, it could be marked on route literature with some general descriptive text.

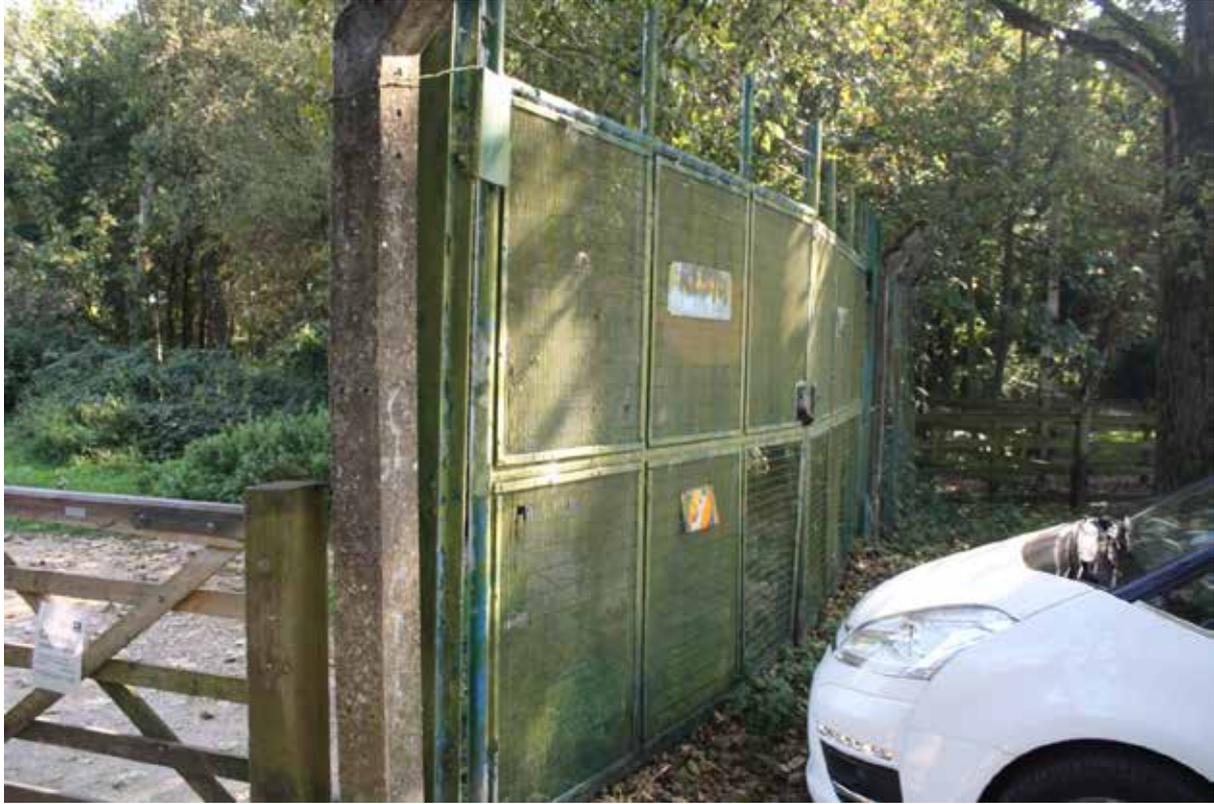
## Blue Gate

One of several peace camps created during opposition to Cruise missiles at airbase in 1980s, no earthworks. The camp was set up on 4th July 1983 and was also known as New Age Gate.

While there are no physical traces of the camp itself, the gate (Gate A) itself still exists – this is one of several surviving sections of the Base perimeter fencing (aside from surrounding the GAMA site). As such, it should be conserved – specialist advice should be sought for this. It would also benefit from an interpretation board - there is a substantial amount of historical imagery and information available for the Gate.

Conservation potential: **HIGH**

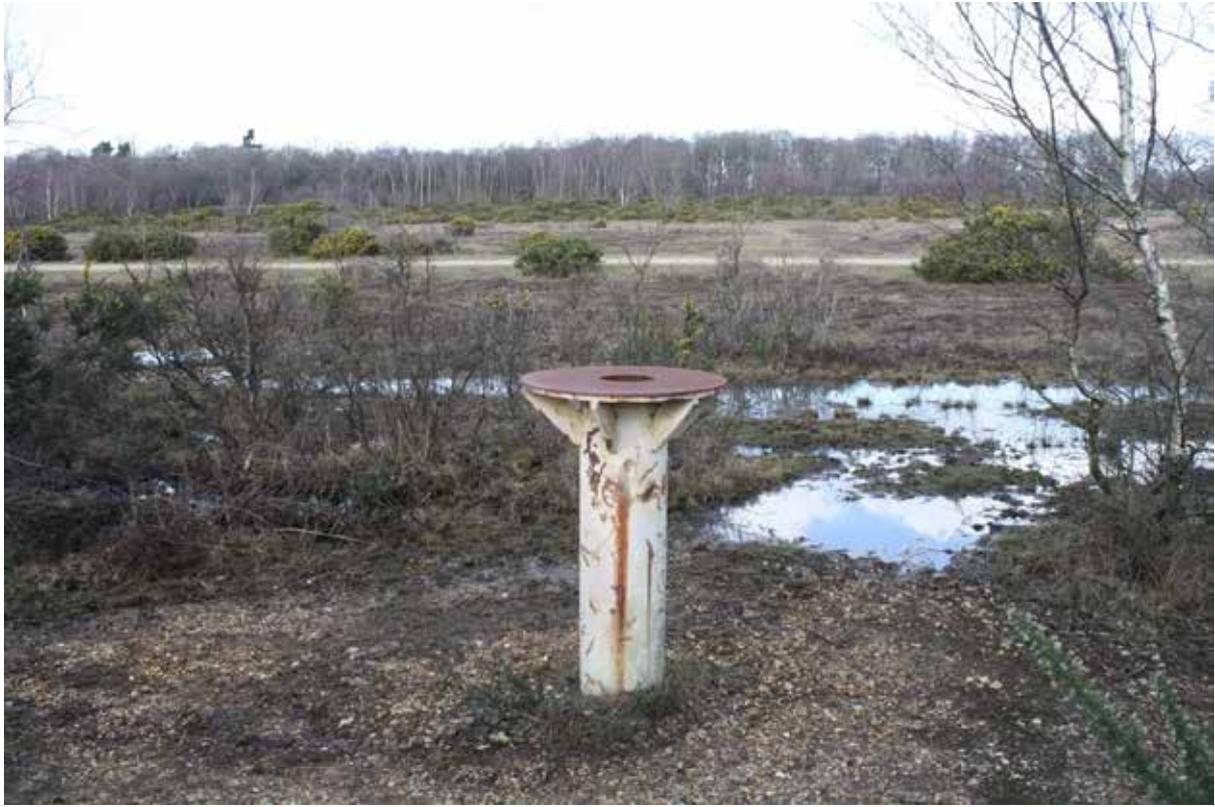
Possible Weather Station/Fire-beater stand (HEMP Feature 520)

Originally described in HEMP document as 'Steel weather station painted white, standing to a height of c. 1.1 metres. The weather station is made from a pipe (with a diameter of 0.30 metres) set vertically in the ground and surmounted by a circular plate. The steel plate is 29mm. thick, 0.75 metres in diameter and has a central hole with a diameter of 0.18 metres'. Local knowledge has suggested that this interpretation is incorrect, and that this and similar structures were internal stanchions used to support the ceiling of underground fuel tanks, reused as fire-beater stands.

Conservation potential: **LOW**

Any maintenance or repairs must be designed to maintain the original character of these structures as far as is possible, and should only be carried out following specialist advice.

This example is set back from the path and will require regular bush/scrub clearance to be visible. While well preserved, there are more visible examples that would probably benefit from interpretation and conservation more.

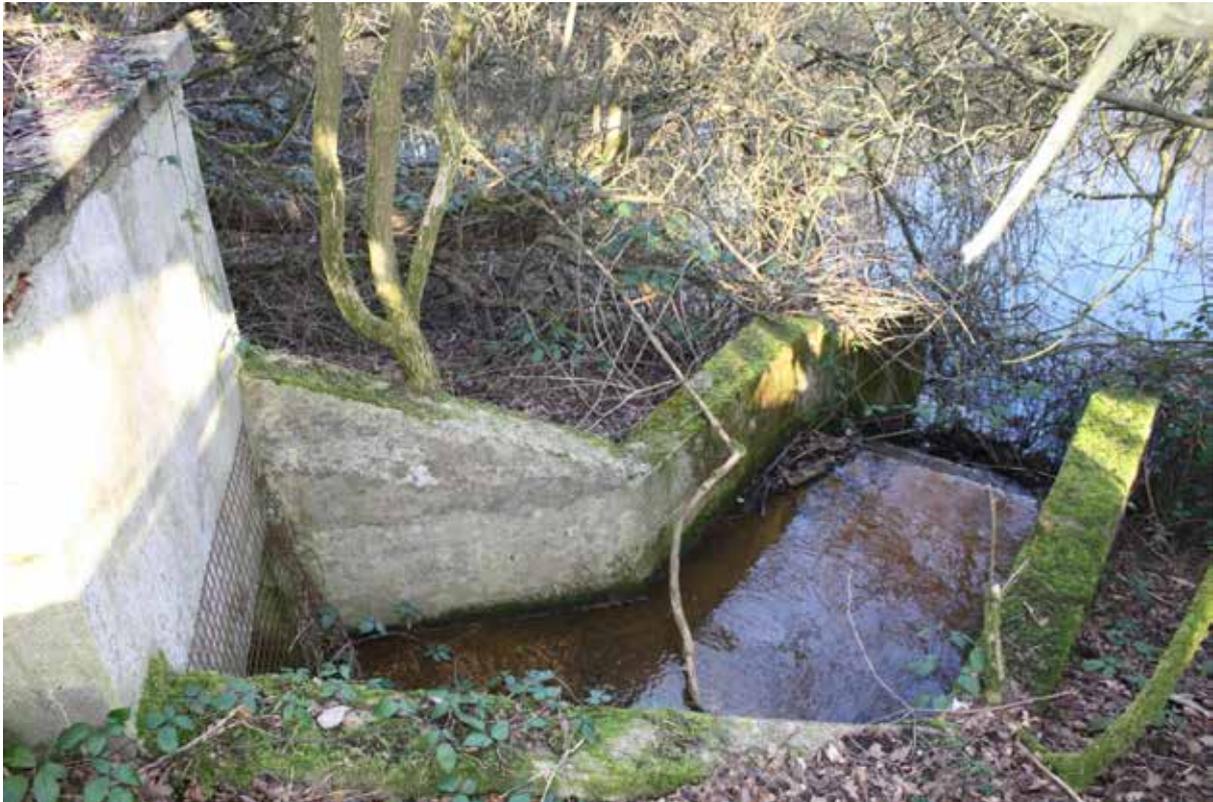
Stormwater balancing pond/tank (HEMP Feature 484)

Rectangular outfall tank fed by a sluice shown on the revised edition OS map of 1976 labelled "Tank"; and on the 1994 masterplan of RAF Greenham as an "Outfall Tank" (RAF Greenham Common Masterplan Sheet 5 of 7). This is likely to be part of the airbase stormwater drainage system installed during the 1951 to 1953 reconstruction of the airbase.

Conservation potential: **MEDIUM**

The tank, sluice and pond are within woodland and, although there is no immediate danger to the structures, some remedial work would be recommended. Structural remains are particularly vulnerable to damage from growing and mature trees, so coppicing and pollarding would be a useful strategy. It must be ensured that anyone working in woodland must be aware of the location of structures, and that any activities take care not to damage them. Roots are less of a problem with more enduring materials such as concrete and modern mortar since they tend to grow alongside or around foundations. However, wind-throw on sites of this type can have a notable adverse impact, resulting in considerable disturbance. Felling the trees, leaving the stumps in place and if possible treating them with herbicide, is the only certain method of preventing this type of damage. Clearly the significance and historical importance of each site needs to be balanced against other management issues before a strategy of this type is implemented.

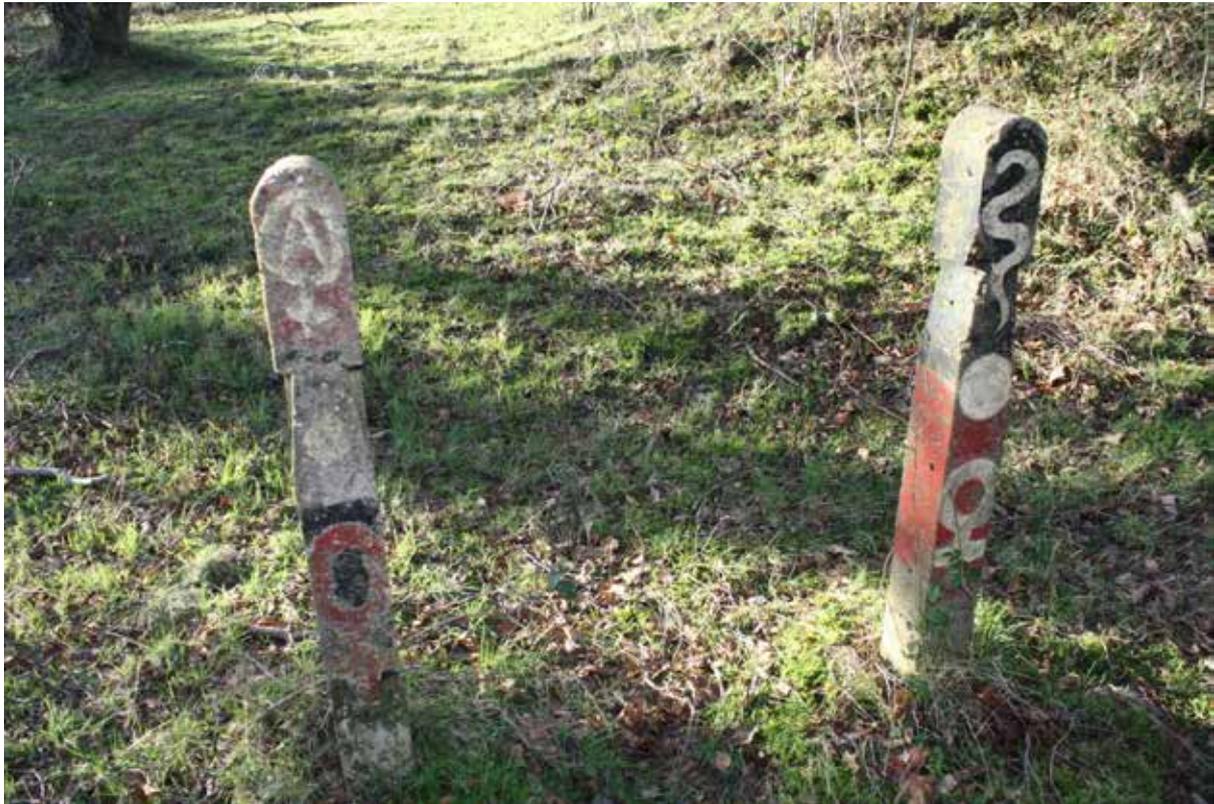
Greenham Common peace camp - Green Gate

One of several peace camps created during opposition to Cruise missiles at airbase in 1980s, it was set up as 'Green Gate' on the 20th January 1983 and has been subsequently researched by John Schofield. The camp was predominantly known as being lesbian, new age, mystical and spiritual.

There are few identifiable traces of any of the peace camps, but painted symbols remain on concrete posts along the western side of Brackenhurst Lane. These symbols include legible words (such as 'Stars In Their Eyes'), female signs, anarchist symbols and a serpent, probably as a reference to the Rainbow Serpent of Aboriginal and Native American mythology. As such, these symbols represent the ideologies and belief systems of the protesters and should be preserved in-situ.

Conservation Potential: **HIGH**

There is also some potential for undiscovered remains below ground, although it is acknowledged that the nature of the camps were quite ephemeral. Advice should be sought from the West Berkshire Archaeological Service if any woodland management is proposed in this area, particularly felling or stump extraction. Similar advice should be sought for any planned scraping activities.

This site represents an excellent surviving example of a protest movement that was of international significance and as such demonstrates high potential for interpretation. An interpretation board should be erected.

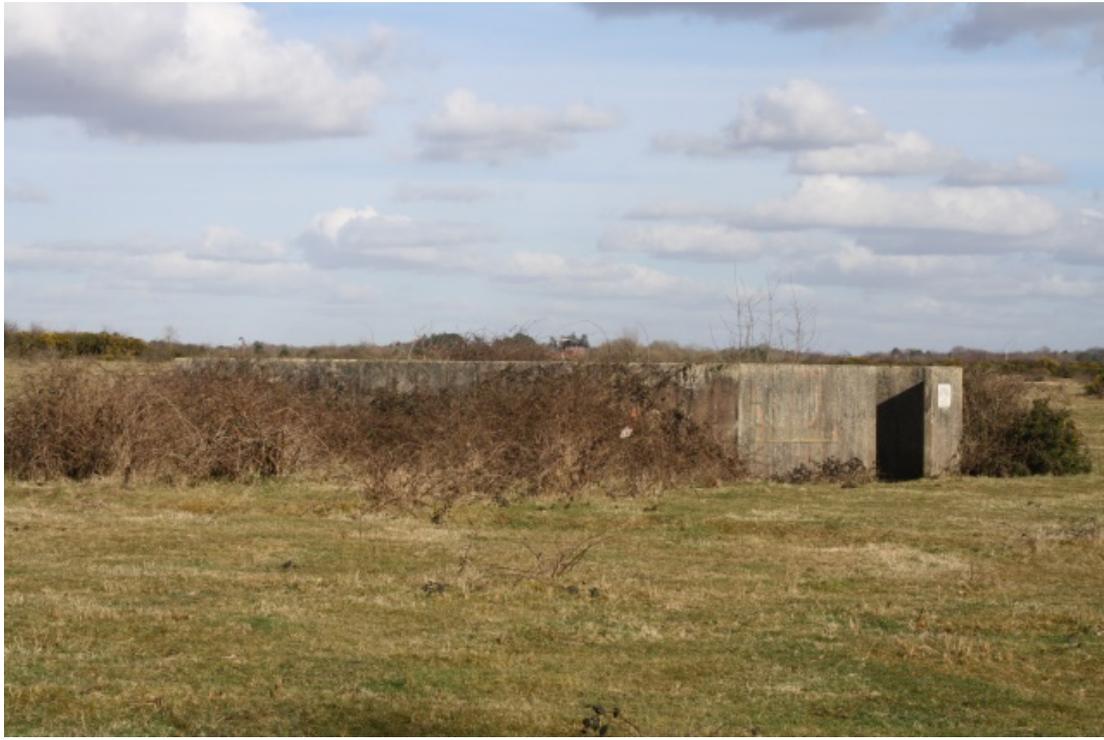
Building (HEMP Feature 471)

Building 325. Electrical sub-station with the electrical installations still inside surrounded by a compound with concrete walls. Can be seen on the 1975 record site plan (Greenham: A Common Inheritance Website); and on the 1994 masterplan of RAF Greenham (RAF Greenham Common Masterplan Sheet 5 of 7, Building 325).

Conservation potential: **MEDIUM**

Regeneration should be controlled using methods appropriate to the setting of the structure or installation. Treatment with herbicide may be the best option around the standing buildings; while grazing may be an effective means of control around some of the smaller pieces of Cold War equipment. Otherwise regular cutting to ensure that the various heritage features are not obscured is recommended. Periodic monitoring and assessment of the impact of scrub levels around features which are currently clear is recommended to identify those in need of clearance. One of the electrical sub-stations is currently serving as a bat-roost, providing a purpose which will help to ensure that it remains in a reasonable state of repair (Building 280, Figure 7, Feature 462), this could be possible solution for this example as well.

There is limited potential for interpretation – a better example would be for Building 280, incorporating the Fire Plane and nearby weather station.

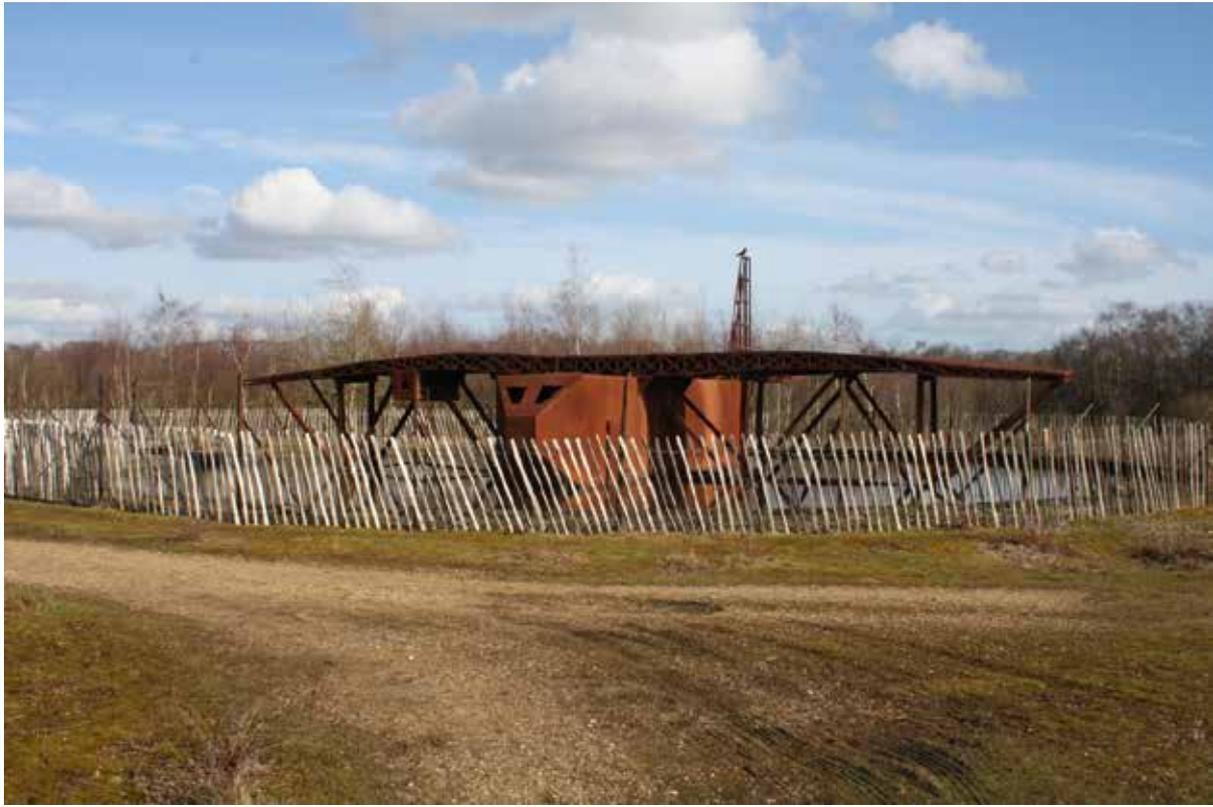
## Fire Plane (HEMP Feature 461)

Mock up plane in form of C-130 (c. 14 metres in length) made by Ray Theodore Welding in Newbury (at a cost of £15,000) and installed in August 1986 (Sayers 2006). This is located in a fenced circular compound and was used for fire fighting training by airfield fire crews and Newbury Fire Brigade (ibid.; and Greenham A Common Inheritance Website). It was fitted with dummy seats and passengers prior to a training exercise and was linked with a pipeline allowing the fuselage to be sprayed with aviation fuel (Sayers 2006). The circular compound is shown on the 1994 masterplan of RAF Greenham, labelled 'Fire fighting exercise area' (RAF Greenham Common Masterplan Sheet 5 of 7).

Conservation potential: **HIGH**

This structure represents a unique survival of this kind of structure and should be preserved as a matter of priority. Any maintenance or repairs must be designed to maintain the original character of these structures as far as is possible, and should only be carried out following specialist advice.

An interpretation board should be erected, which could also incorporate building 280 and weather station 463.

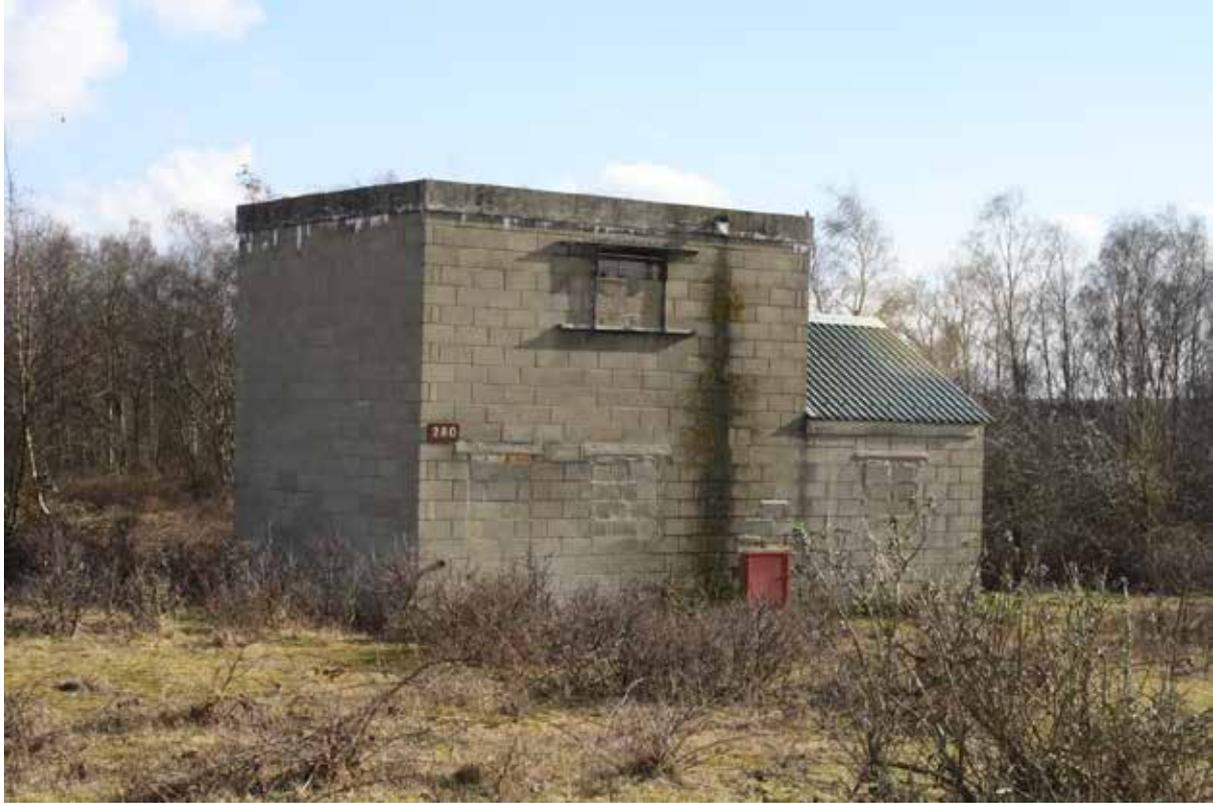
Building (HEMP Feature 462)

Building 280 – Classified as an Electrical sub-station in HEMP document, but suggested to be a training building utilised by airbase fire brigade to practice building evacuation. Built of concrete breeze blocks identified by military number plaque 280; main part with concrete slab roof; south-western annex with corrugated roof. Currently being used as a roost for bats (Greenham: A Common Inheritance Website). This is visible on the 1994 masterplan of RAF Greenham (RAF Greenham Common Masterplan Sheet 6 of 7).

Conservation potential: **HIGH**

Regeneration should be controlled using methods appropriate to the setting of the structure or installation. Treatment with herbicide may be the best option around the standing buildings; while grazing may be an effective means of control around some of the smaller pieces of Cold War equipment. Otherwise regular cutting to ensure that the various heritage features are not obscured is recommended. Periodic monitoring and assessment of the impact of scrub levels around features which are currently clear is recommended to identify those in need of clearance.

This could be included on an interpretation panel that incorporates the Fire Plane and possible Weather Station/ Fire beater stand 463 – mention should be made that this is a military structure now with positive re-use for wildlife conservation

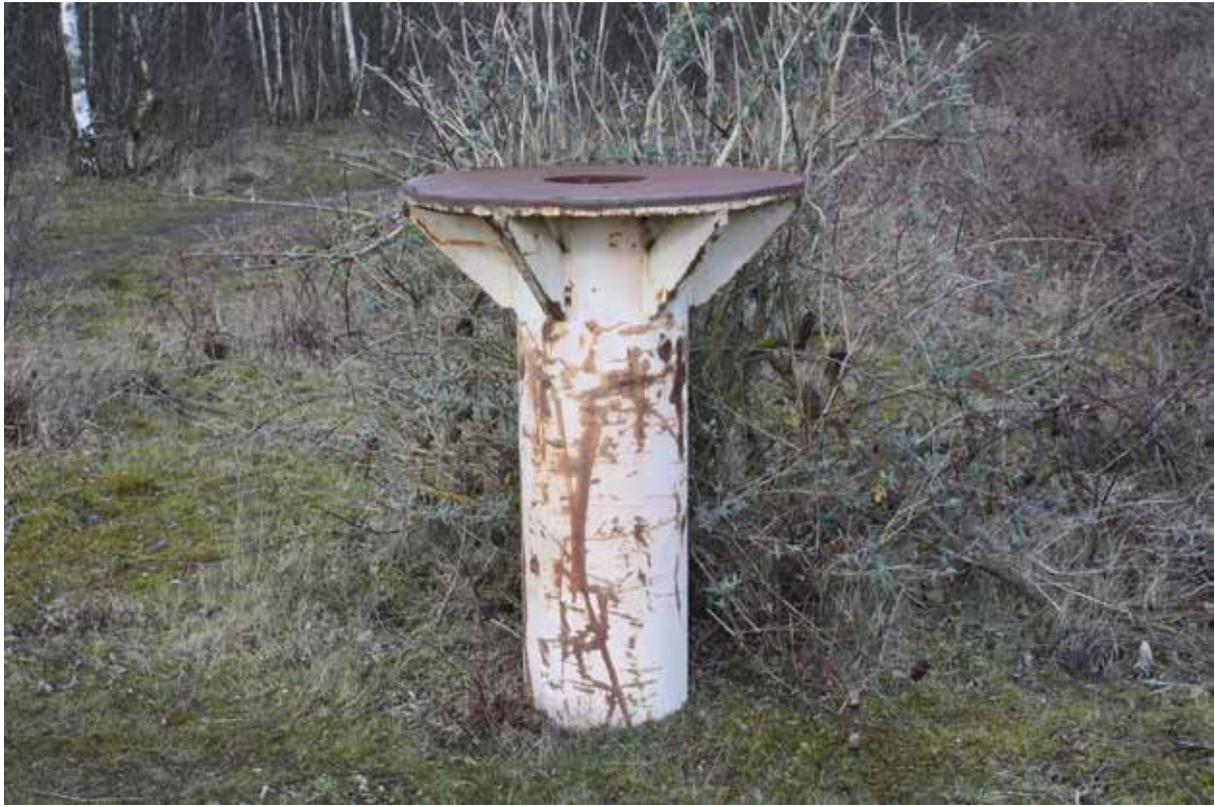
Possible Weather Station/ Fire beater stand (HEMP Feature 463)

Originally described in HEMP document as 'Steel weather station painted white, standing to a height of c. 1.1 metres. The weather station is made from a pipe (with a diameter of 0.30 metres) set vertically in the ground and surmounted by a circular plate. The steel plate is 29mm. thick, 0.75 metres in diameter and has a central hole with a diameter of 0.18 metres'. Local knowledge has suggested that this interpretation is incorrect, and that this and similar structures were internal stanchions used to support the ceiling of underground fuel tanks, reused as fire-beater stands.

Conservation potential: **HIGH**

Any maintenance or repairs must be designed to maintain the original character of these structures as far as is possible, and should only be carried out following specialist advice.

This could be incorporated into an interpretation board including the Fire Plane and building 280. Its position should be marked on route literature along with the location of other examples.

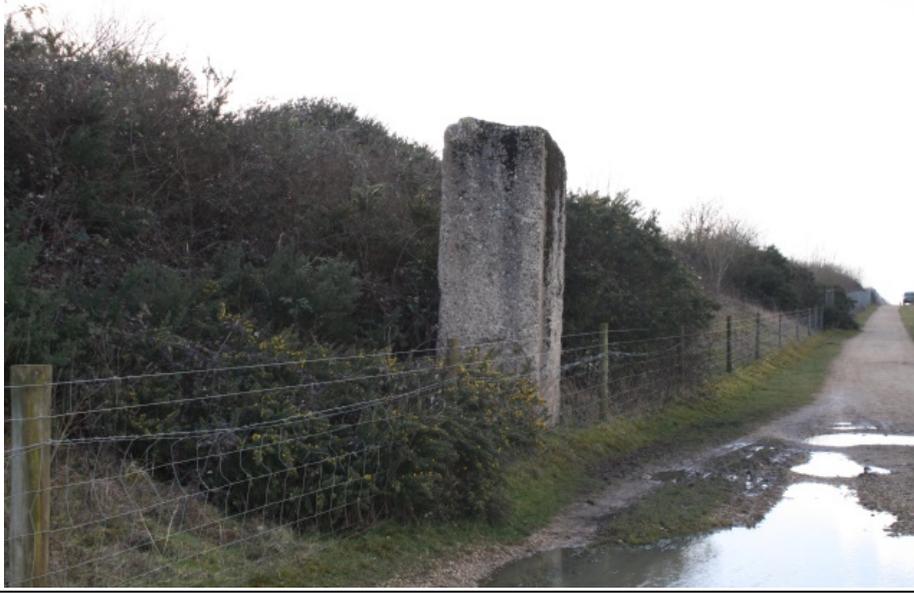
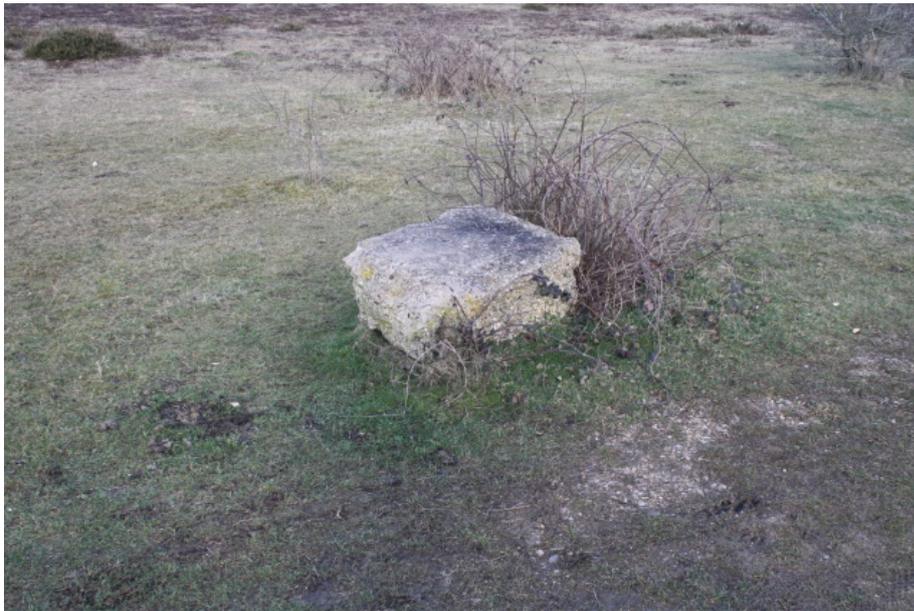
## Historic Boundary Markers

Local knowledge has confirmed that these concrete blocks were originally one piece and used to mark the historic South West boundary between Greenham and Crookham Commons

Conservation potential: **LOW**

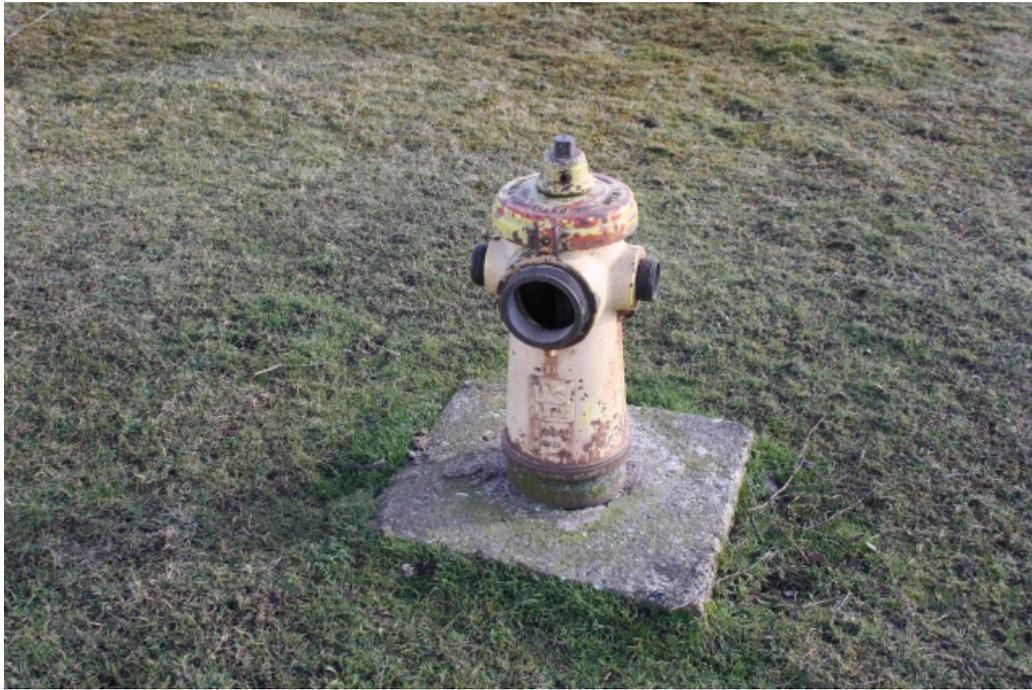
Fire Hydrant (HEMP Feature 60?)

Iron fire hydrant with two side and one front cap, painted cream with brown top and side caps, with traces of red and yellow paint on the top and yellow paint on caps; standing to a height of 0.7 metres and set on a square concrete pad (c. 0.6 metres across). Has "VSP OPEN 5 1/4 VO" on the top; "655510 5 1/4 VO 10106 D1" on north side; "D1 US PIPE 1986 AWWA PAT. 4.123.285" on south side; and "TOPSIDE USP 668860" on south side base.

Conservation potential: **MEDIUM**

Any maintenance or repairs must be designed to maintain the original character of these structures as far as is possible, and should only be carried out following specialist advice.

This is not particularly well preserved example, but may benefit from conservation and is visible from the path. Its position could be marked on route literature along with other surviving fire hydrants.

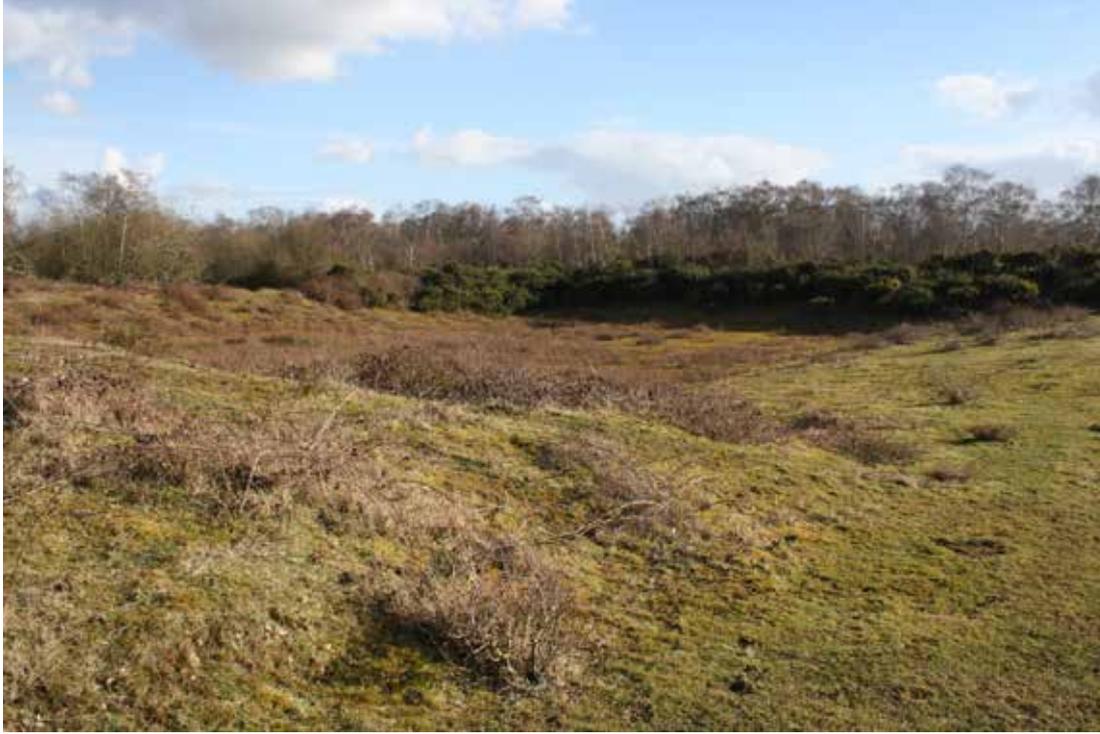
Feature = Quarry? Water Tank? (HEMP Feature 390)

Originally recorded as 'Large irregular quarry defined by a steep scarp around the footslopes of a combe and associated with an extensive area of mineral extraction' in HEMP. Local knowledge suggests that this interpretation is incorrect, and that the feature may have been a water storage tank associated with the airbase.

Conservation potential: **LOW**

Control of the scrub and invasive species, such as rhododendrons and bramble, on earthworks and sites with buried remains is recommended. Root damage can be an issue, while scrubby layers provide an attractive habitat for burrowing animals, which cause considerable damage. Where earthworks are present unchecked scrub will mask the features, make them more vulnerable to accidental damage and hide them from public view. For mature scrub, methods which will not cause ground disturbance must be used. In practice this generally means cutting by hand; using herbicides where necessary; and leaving stumps, stems and roots in place. Once cleared, periodic monitoring to identify sites where regeneration requires renewed scrub control is recommended. Grazing is an option as a traditional strategy for controlling regeneration, although it may not be practical on the commons boundaries or in wet areas, where earthworks are vulnerable to ground disturbance. If grazing is to be used care must be taken to monitor the stocking levels to ensure that the vegetation control is effective without causing erosion.

This feature has limited interpretation potential, but could be marked on route literature.

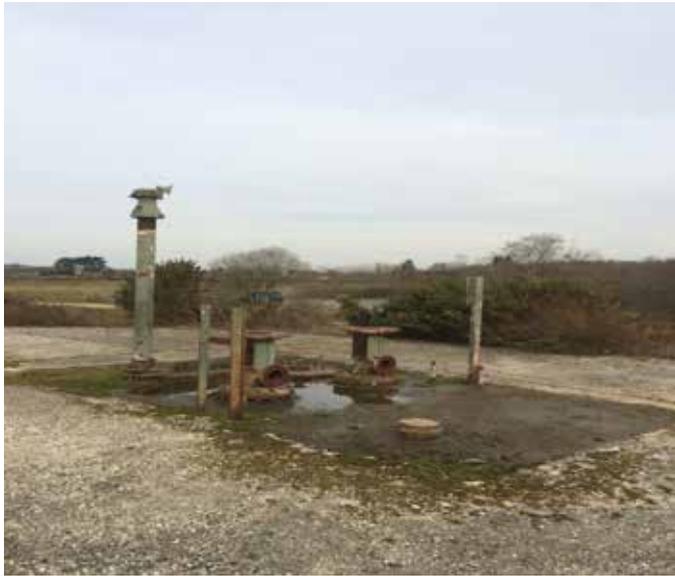
POL (HEMP Feature 1/ Coppice Walk)

A well preserved example of a Petroleum Oil and Lubricants (POL) Tank built in 1951 and 1953, consisting of intact above and below ground structures. This was left in situ as a reminder of the Cold War, and was one of the largest on the base.

Conservation Potential: **HIGH**

This is a good surviving example of the Base infrastructure and would benefit from conservation and interpretation. The main danger is the corrosion of the metal headgear and advice should be sought from specialist conservators, with the aim of preserving the original character as far as possible. Scrub clearance should be undertaken and monitoring undertaken.

This would benefit from an interpretation board if possible. This could include materials such as photos of the interior of a similar tank – one of these exists on the 'Greenham: A Common Inheritance Website. It should be shown on route literature along with explanatory text

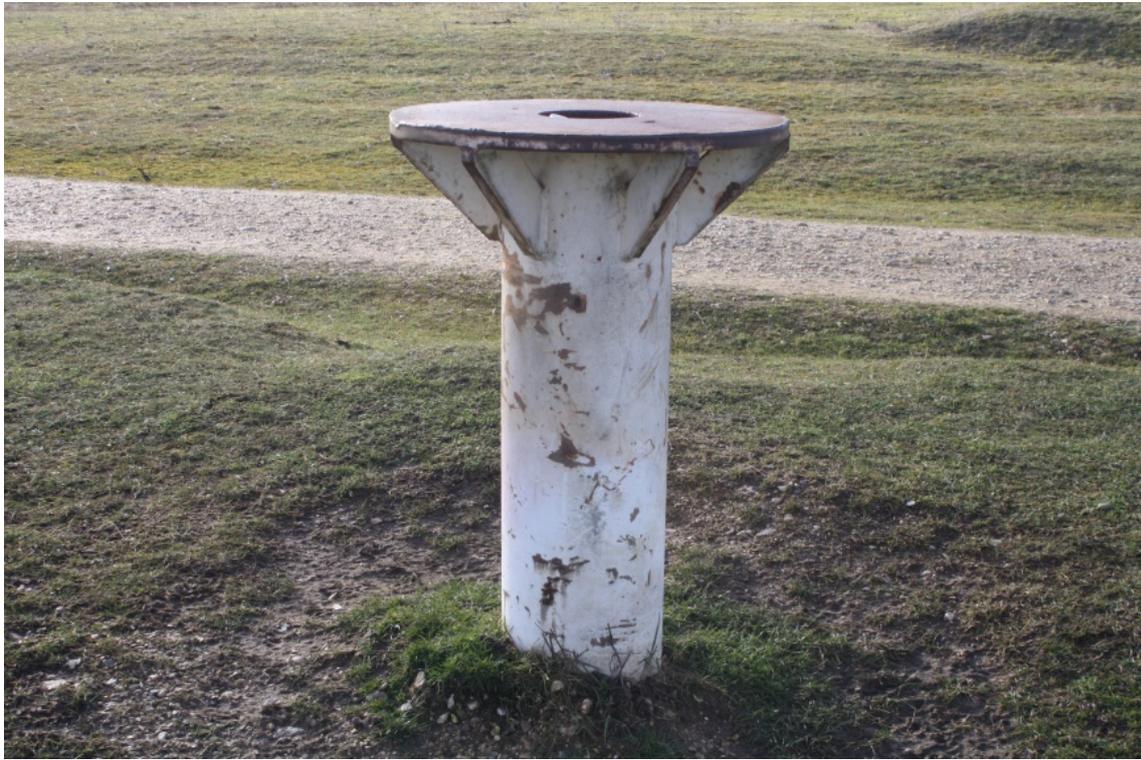
Possible Weather station/ Fire beater stand (HEMP Feature 13)

Originally described in HEMP document as 'Steel weather station painted white, standing to a height of 1.1 metres. The paint has been scored by vertical lines with cross-members. The weather station is made from a pipe (with a diameter of 0.28 metres) set vertically in the ground and surmounted by a circular plate. The steel plate is 29mm. thick, 0.75 metres in diameter and has a central hole with a diameter of 0.183 metres'. Local knowledge has suggested that this interpretation is incorrect, and that this and similar structures were internal stanchions used to support the ceiling of underground fuel tanks, reused as fire-beater stands.

Conservation Potential: **HIGH**

Any maintenance or repairs must be designed to maintain the original character of these structures as far as is possible, and should only be carried out following specialist advice.

This example has reasonable potential as clearly visible from trails – rather than an interpretation board, it could be marked on a route literature with some general descriptive text.

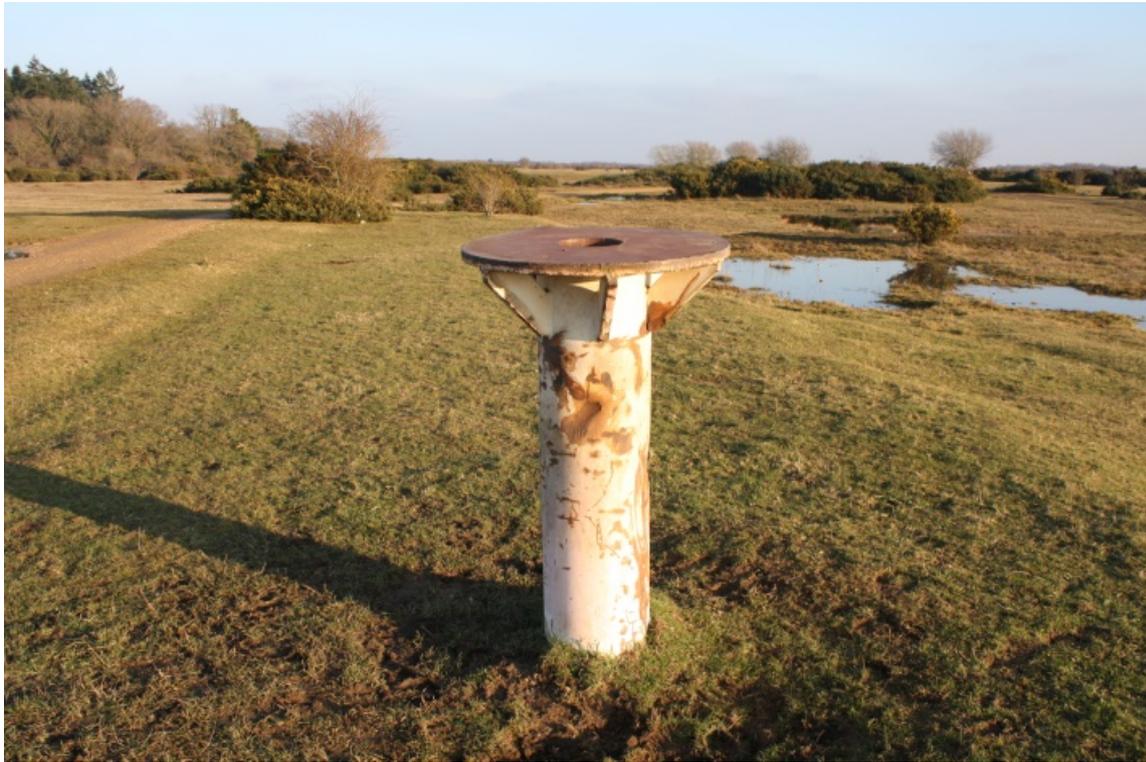
Possible Weather Station/ Fire beater stand (HEMP Feature 136)

Originally described in HEMP document as 'Steel weather station close to the north of the Runway Cross (Project ID 75); painted white, standing to a height of 1.3 metres. The paint has been scored by vertical lines with cross-members. The weather station is made from a pipe (with a diameter of 0.32 metres) set vertically in the ground and surmounted by a circular plate. The steel plate is 30mm. thick, 0.75 metres in diameter and has a central hole with a diameter of 0.185 metres'. Local knowledge has suggested that this interpretation is incorrect, and that this and similar structures were internal stanchions used to support the ceiling of underground fuel tanks, reused as fire-beater stands.

Conservation potential: **HIGH**

Any maintenance or repairs must be designed to maintain the original character of these structures as far as is possible, and should only be carried out following specialist advice.

This example has reasonable potential as clearly visible from trails – rather than an interpretation board, it could be marked on a route literature with some general descriptive text.

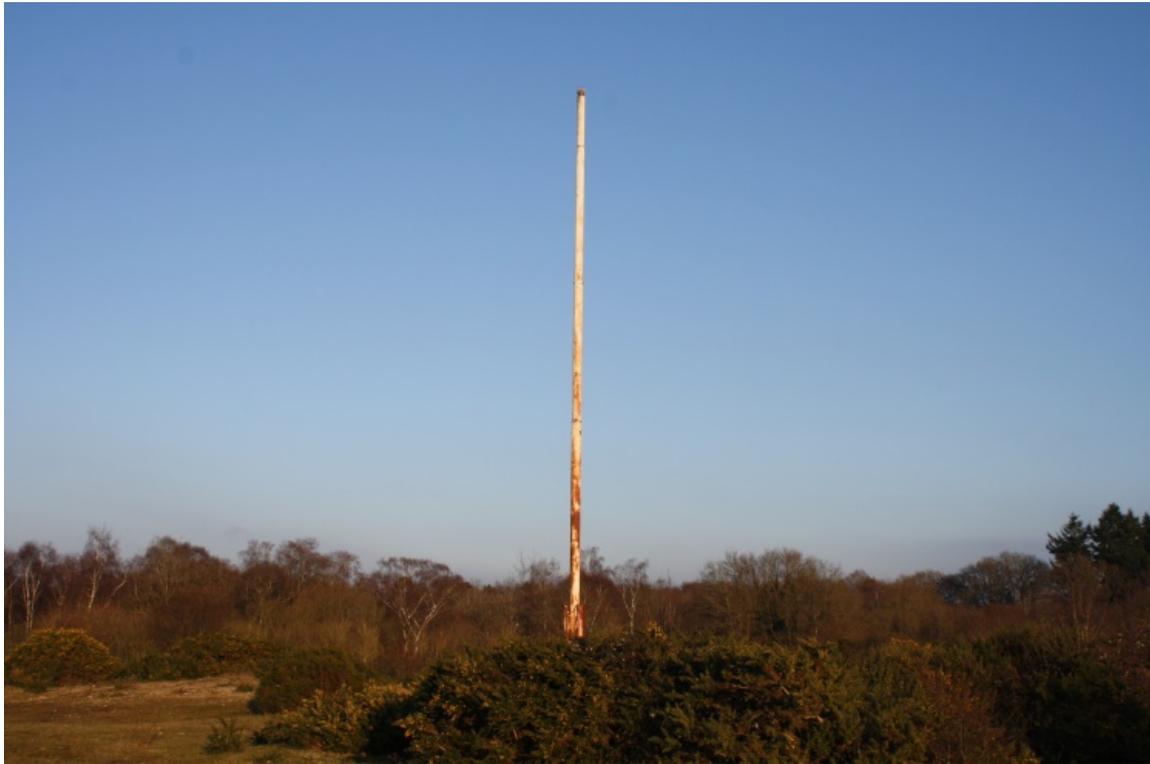
Flag Pole (HEMP Feature 137)

Flag pole made from three tubular sections secured by a bolt to two I beams with large weights at one end near the base (for lowering the pole). The pole is set in a square concrete slab (1.5 metres across). The I beams are stamped "B.S.C. GLENGARNOCK G.T. BRITAIN". Produced by the British Steel Corporation in the Glencarnock works which were taken over from Colvilles in 1967 and closed in 1985 (Grace's Guide Glencarnock Iron and Steel Company).

Conservation potential: **HIGH**

Any maintenance or repairs must be designed to maintain the original character of these structures as far as is possible, and should only be carried out following specialist advice.

The flagpole is a unique surviving aspect of the base and should be conserved as a high priority. Historical information is available that could be included on an interpretation panel, possibly in conjunction with Fire hydrant 150 and Building 148. It should be shown on route literature along with interpretive material

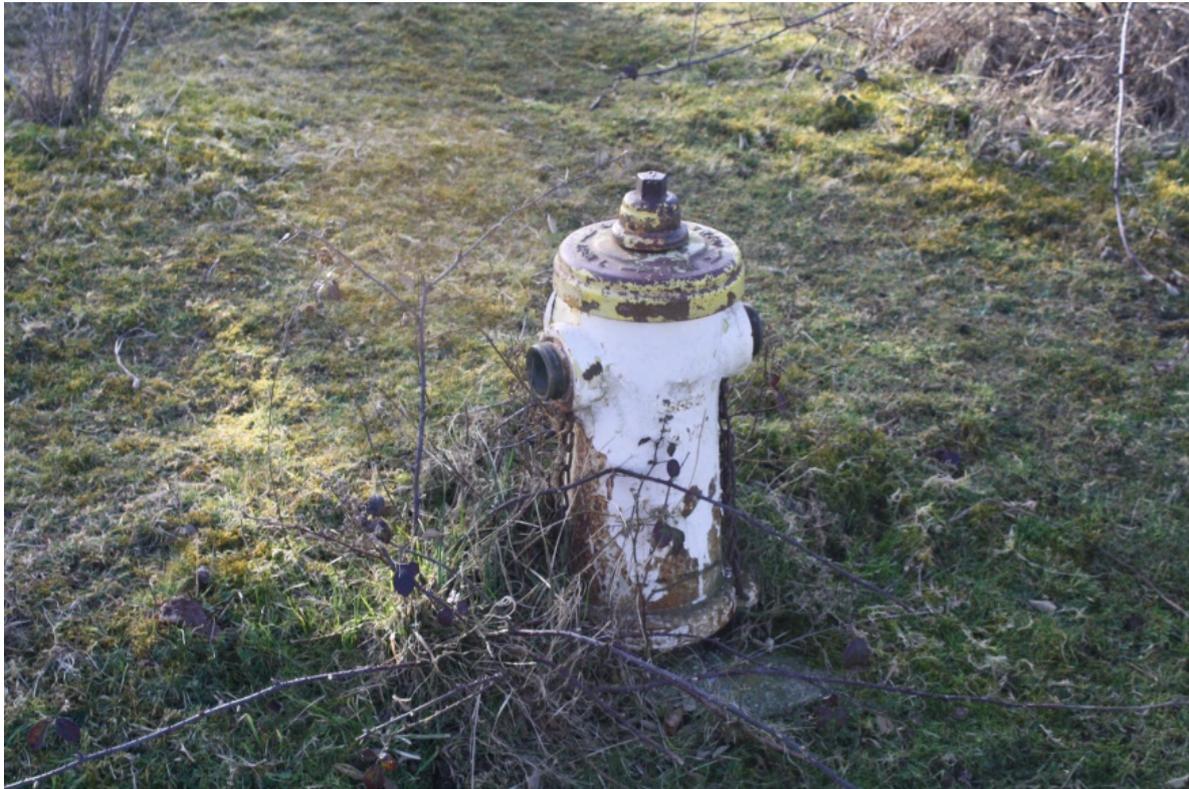
Fire Hydrant (HEMP Feature 150)

Iron fire hydrant painted cream with brown paint on the top and side caps, which also have traces of yellow paint (the front side cap is missing); standing to a height of 0.7 metres and set on a square concrete pad (c. 0.6 metres across). Has "VSP OPEN 5 1/4 VO" on the top; "655510 5 1/4 VO 10106 D1" on one side; "D1 US PIPE 1986 AWWA PAT. 4.123.285" on the other side above "TOPSIDE USP 668860" on the base.

Conservation potential: **MEDIUM**

Any maintenance or repairs must be designed to maintain the original character of these structures as far as is possible, and should only be carried out following specialist advice.

This is not particularly well preserved example, but may benefit from conservation and is visible from the path. Its position could be marked on route literature along with other surviving fire hydrants
