# Greenham Common Walkover Survey

West Berkshire Council - 2016

Alex Godden - Archaeological Officer

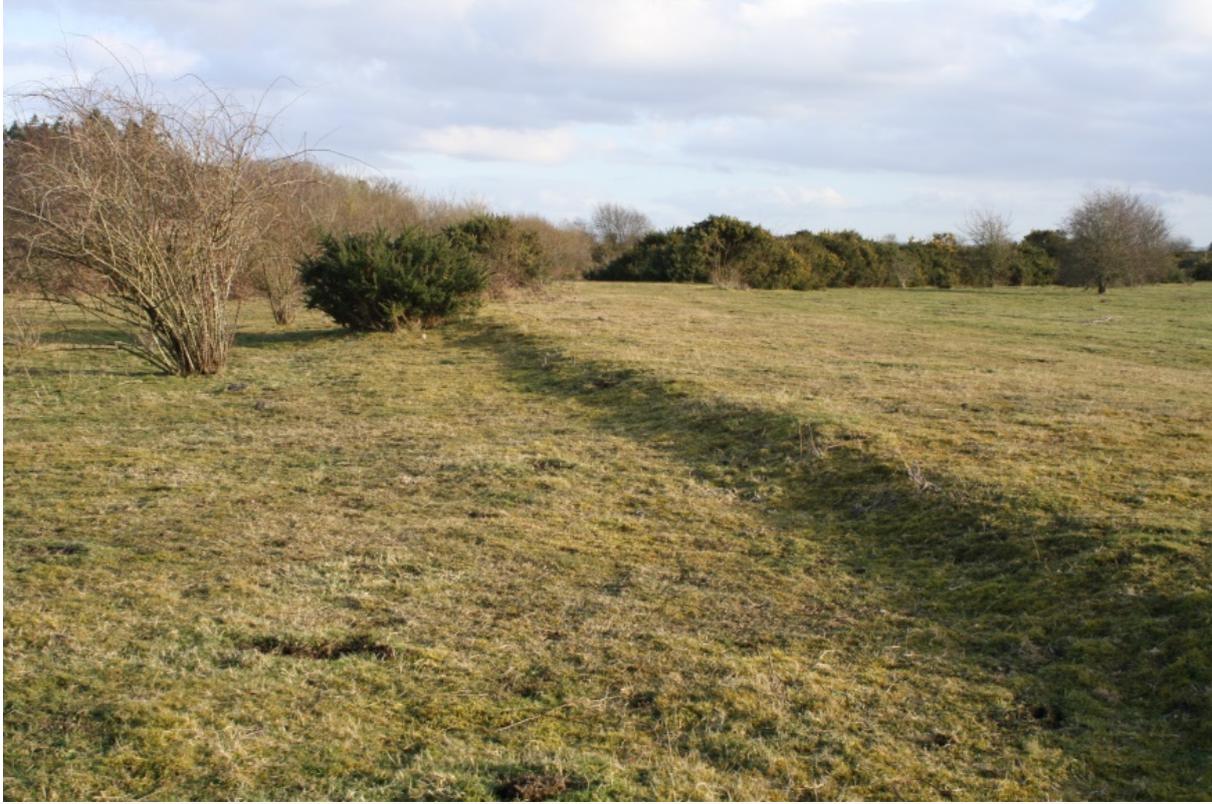
Bank (HEMP Feature 149)

Low bank on a south-east to north-west alignment (c. 1 metre wide), reduced in places, following the side of an old track for much of its length. The feature has been removed where it enters a large area of ground reduction. The line of the road can be seen on the 1994 masterplan of RAF Greenham and an AP taken 16th May 1998.

Conservation potential: **LOW**

Control of the scrub using hand cutting, leaving trunks, stems and roots in place is recommended, but in some cases the level of clearance may need to be balanced against other considerations. Total clearance can introduce new management issues particularly where earthworks are concerned, such as erosion through recreational activities like mountain biking or as a result of soil instability and natural weathering. The last could arise on the steep recent scarps marking the line of the Cold War runway which are still under pioneer vegetation. One solution is to encourage the growth of species which are beneficial to the stable maintenance of earthworks, such as grasses and heather. Once again, grazing using a suitable stocking level provides a traditional and effective method of controlling regeneration

There appears to be no immediate need for conservation, but this is a visible feature from the path and may benefit from inclusion on any route literature.

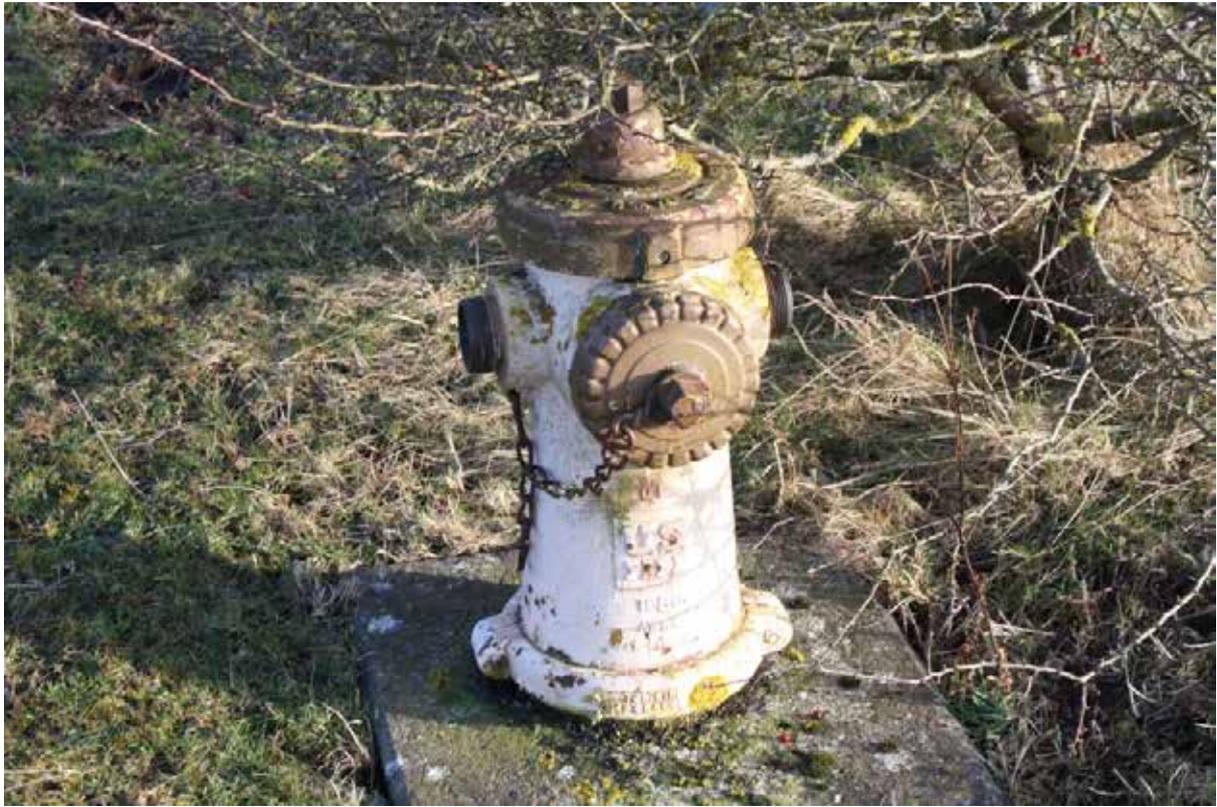
Fire Hydrant (HEMP Feature 143)

Iron fire hydrant painted cream with brown paint on the top and front cap, which also have traces of yellow paint (the side caps are missing) standing to a height of 0.7 metres and set on a square concrete pad (c. 0.6 metres across). Has "VSP OPEN 5 1/4 VO" on the top; "655510 5 1/4 VO 10106 D1" on one side; "D1 US PIPE 1986 AWWA PAT. 4.123.285" on the other side above "TOPSIDE USP 668860" on the base.

Conservation potential: **HIGH**

Any maintenance or repairs must be designed to maintain the original character of these structures as far as is possible, and should only be carried out following specialist advice.

This is a well preserved example that would benefit from conservation, but it is visible from the path scrub clearance would make the hydrant more obvious, it's position should be marked on route literature along with other fire hydrants.

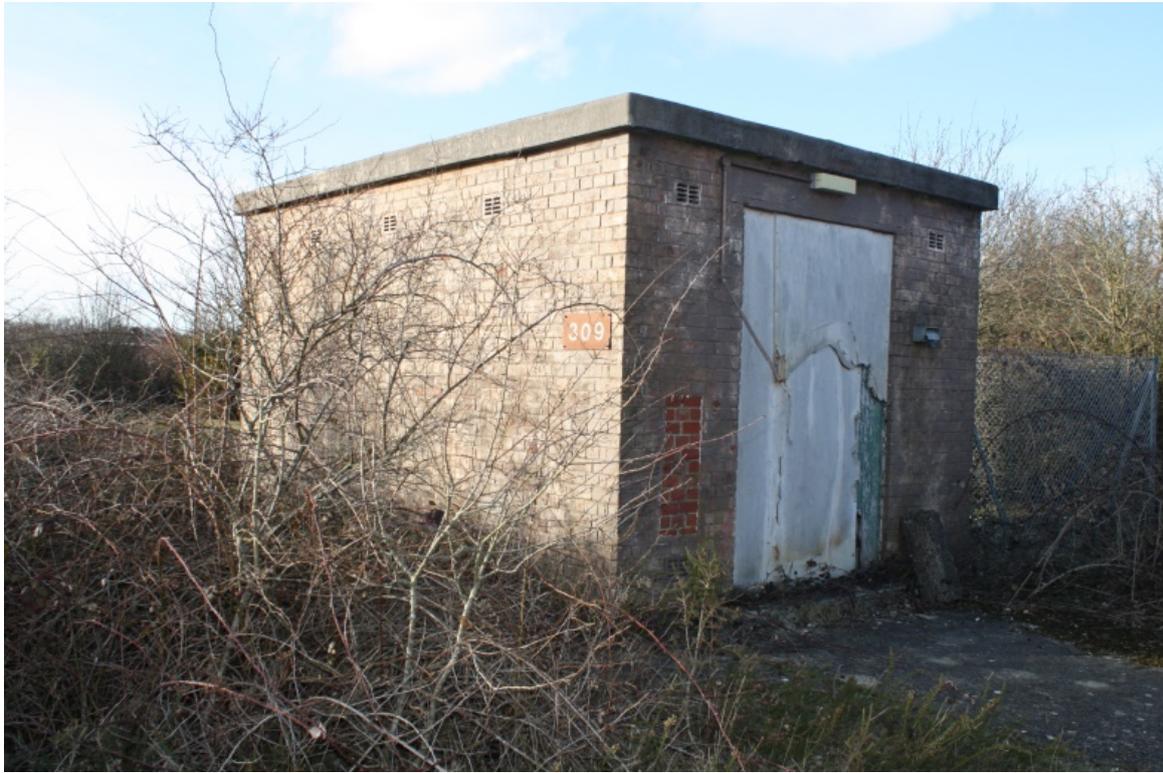
Electricity sub-station (HEMP Feature 148)

Small electricity sub-station constructed with modern brick (marked with military building number plaque 309) with a broken plank constructed wooden door on the eastern side and a wire and mesh compound to the north. The approach road and part of its kerb is still visible. Can be seen on the 1975 record site plan (Greenham: A Common Inheritance Website); the 1994 masterplan of RAF Greenham (RAF Greenham Common Masterplan Sheet 2 of 7); and an AP taken 16th May 1998.

Conservation potential: **MEDIUM**

Regeneration should be controlled using methods appropriate to the setting of the structure or installation. Treatment with herbicide may be the best option around the standing buildings; while grazing may be an effective means of control around some of the smaller pieces of Cold War equipment. Otherwise regular cutting to ensure that the various heritage features are not obscured is recommended. Periodic monitoring and assessment of the impact of scrub levels around features which are currently clear is recommended to identify those in need of clearance.

Another airbase building is currently serving as a bat-roost, providing a purpose which will help to ensure that it remains in a reasonable state of repair (Building 280, Figure 7, Feature 462) – this may be possible solution for this example as well. There is limited scope for interpretation, but there may be some scope for inclusion on a board associated with the flagpole. Otherwise, it should be marked on route literature.

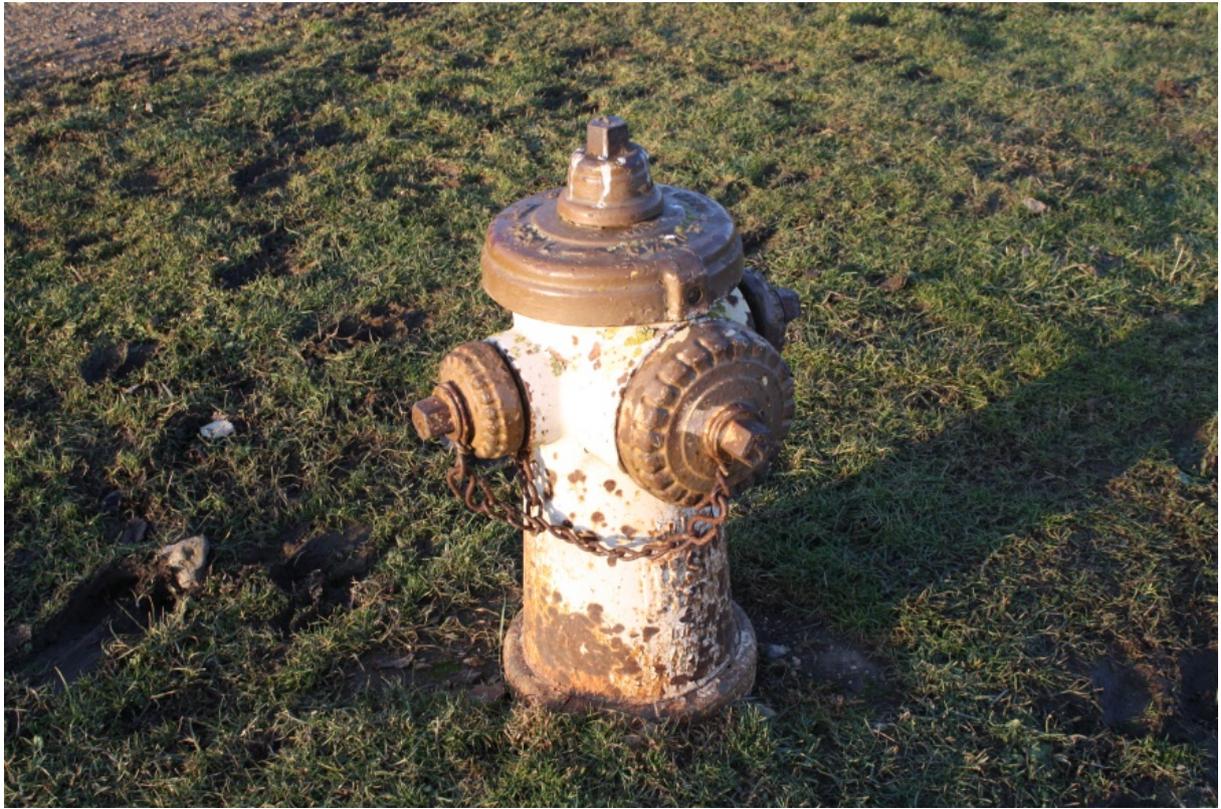
Fire Hydrant (HEMP Feature 139)

Iron fire hydrant painted cream with brown paint on the base, top and side caps, which also have traces of yellow paint; standing to a height of 0.7 metres and set on a square concrete pad (c. 0.6 metres across). Has "VSP OPEN 5 1/4 VO" on the top; "655510 5 1/4 VO 10106 D1" on one side; "D1 US PIPE 1986 AWWA PAT. 4.123.285" on the other side above "TOPSIDE USP 668860" on the base.

Conservation potential: **HIGH**

Any maintenance or repairs must be designed to maintain the original character of these structures as far as is possible, and should only be carried out following specialist advice.

This is a very well preserved example and should be conserved. Its position should be marked on any route literature along with other fire hydrants.

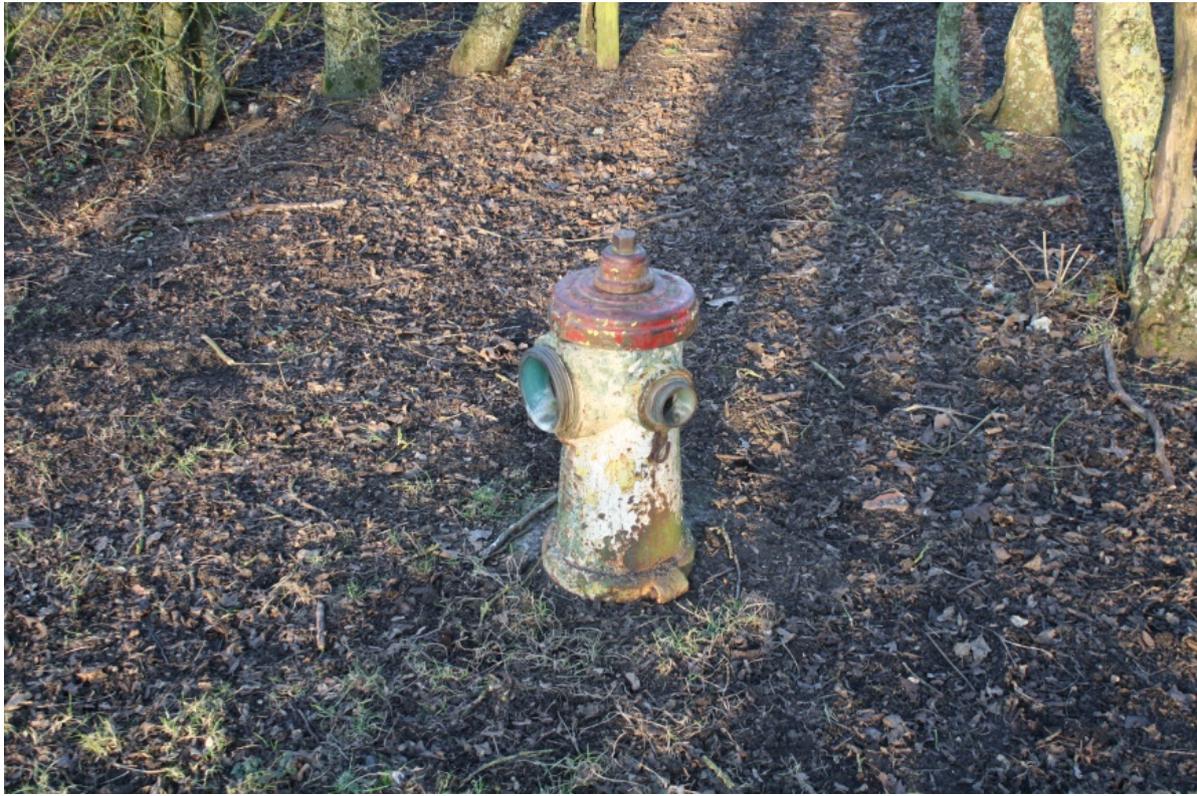
Fire Hydrant (HEMP Feature 154)

Iron fire hydrant painted cream with brown, red and yellow paint on the top, which also has traces of yellow paint (all three of the side caps are missing); standing to a height of 0.7 metres and set on a square concrete pad (c. 0.6 metres across). Has "VSP OPEN 5 1/4 VO" on the top; "655510 5 1/4 VO 10106 D1" on one side; "D1 US PIPE 1986 AWWA PAT. 4.123.285" on the other side above "TOPSIDE USP 668860" on the base.

Conservation potential: **MEDIUM**

Any maintenance or repairs must be designed to maintain the original character of these structures as far as is possible, and should only be carried out following specialist advice.

This example would benefit from conservation, but it is already missing the side caps and is not visible from path – however, its position could be marked on any route literature.

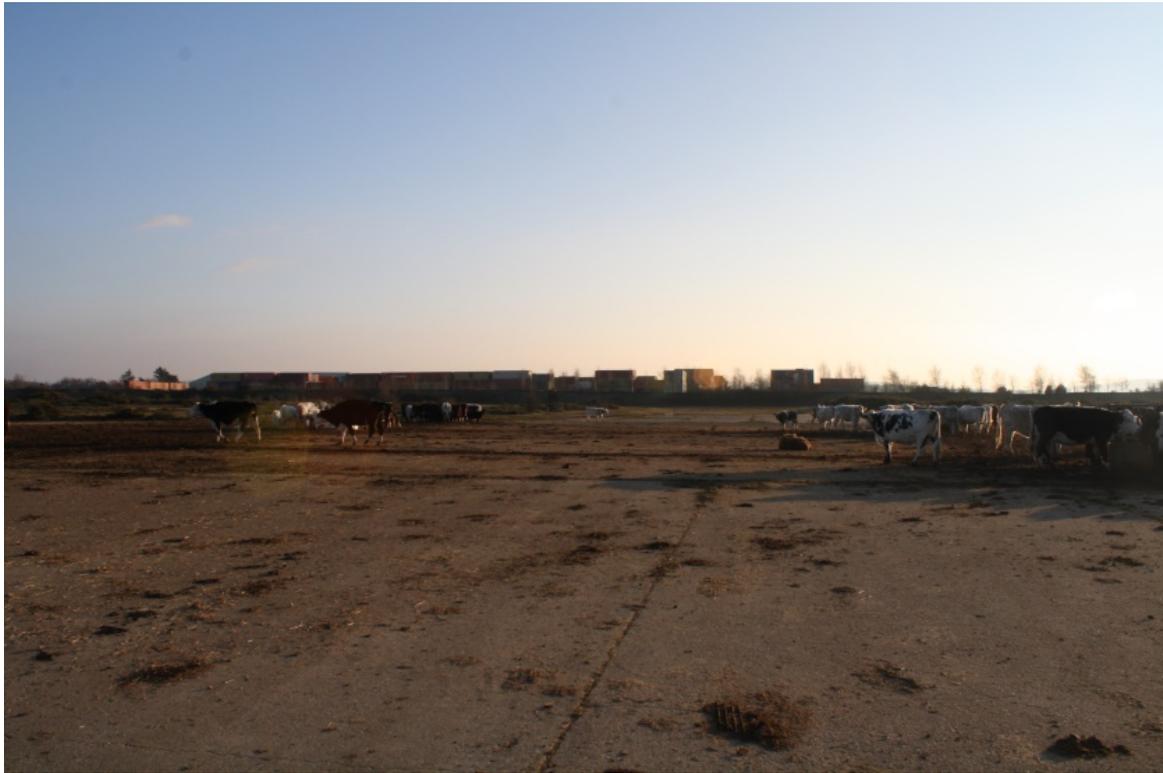
Runway (HEMP Feature 75)

Small remaining intersection of what was once the longest runway in Europe, built during the Cold War; intersection between the runway and access roads leading to the two taxiways made of concrete and tarmac

Conservation potential: **MEDIUM**

Periodic monitoring and assessment of the impact of scrub levels around features which are currently clear is recommended to identify those in need of clearance

This surviving piece of the runway has high interpretation potential, considering its survival and the existence of readily available archive material. However, the current use of the runway for livestock would make both recreational access and conservation problematic. The surface of the runway should be kept clear if possible, and livestock feeding redirected elsewhere. An interpretation board could be considered, but this would not be feasible if livestock still have access. Reference to the runway in the form of text and maybe photos should be included in any route literature.
