# Martindale Pound Walkover Survey

West Berkshire Council - 2016

## Martindale Pound Walkover Survey August 2015

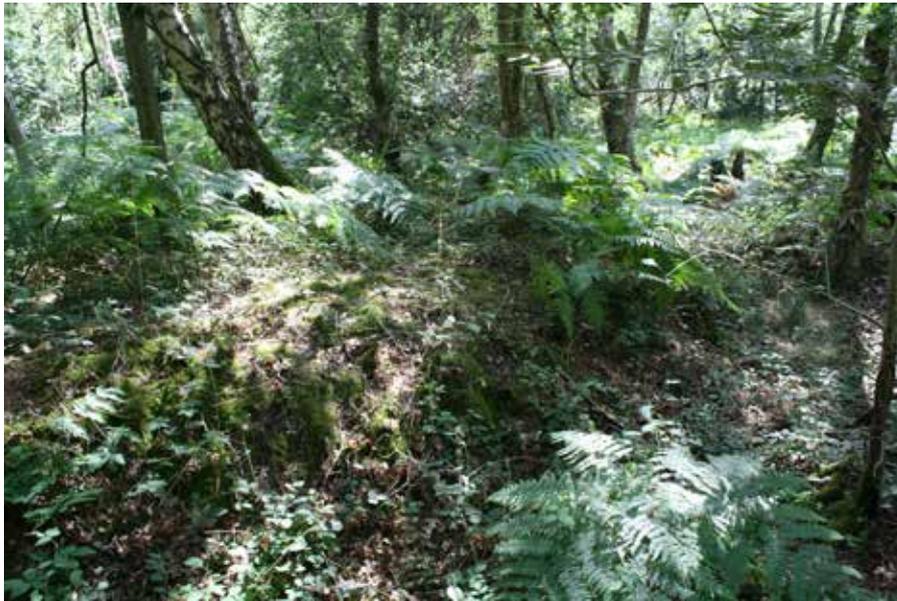
A site visit and visual survey was carried out by Alex Godden (West Berkshire Council Archaeological Officer) on 7<sup>th</sup> August 2015. The site itself was under dense vegetation, but the earthwork of bank marking the edges of the pond were observed to be very well preserved on the north, west and southern sides. The eastern sides were not observed, but this could be down to vegetation cover as opposed to erosion.

*Western earthwork bank*

The chances of wind throw can be minimised by ensuring that the health of the trees is checked on a regular basis as part of an annual tree safety inspection. Traditional practices such as coppicing and pollarding present other options for reducing the likelihood of this kind of damage. Maintaining a canopy and planting scheme that minimises the chances of wind-throw occurring can also be helpful. In a similar manner, the careful planning of woodland clearance should ensure that earthworks or fragile buried remains are not exposed to the risk of this type of damage.

Control of the scrub and invasive species on the site is recommended. Root damage can be an issue, while scrubby layers provide an attractive habitat for burrowing animals, which cause considerable damage. In addition, unchecked scrub will mask

the feature, making the site more vulnerable to accidental damage and hidden from public view. For mature scrub, methods which will not cause ground disturbance must be used. In practice this generally means cutting by hand; using herbicides where necessary; and leaving stumps, stems and roots in place. Once cleared, periodic monitoring to identify sites where regeneration requires renewed scrub control is recommended .

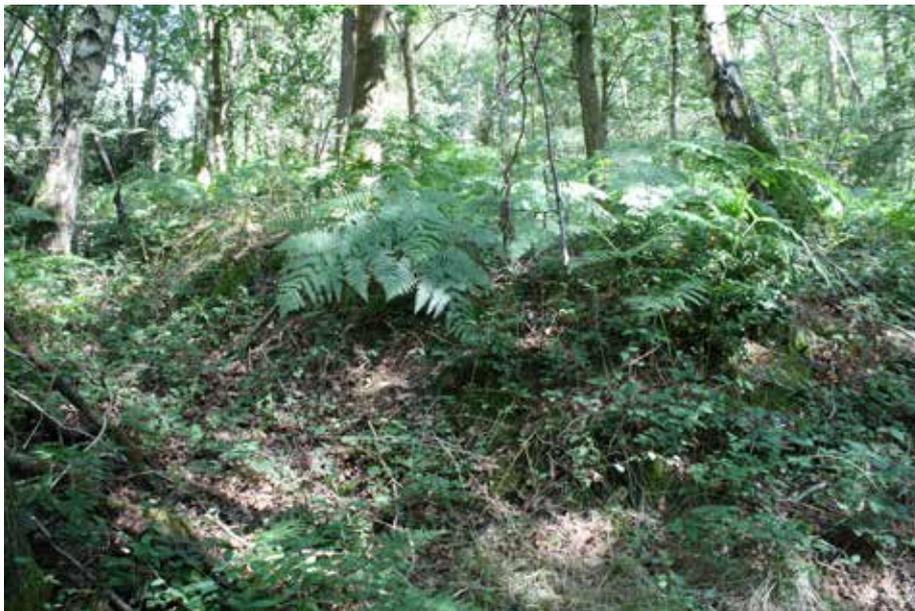
*South West Corner of earthwork bank*

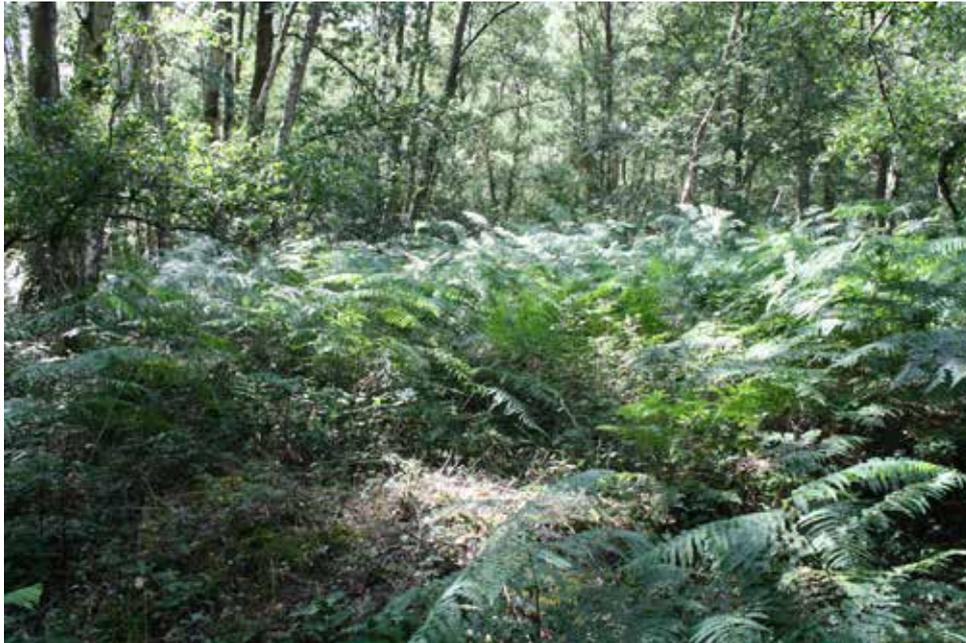
*Northern earthwork bank*

There are trees on both the bank itself and within the interior of the pound, some of which appear to be of some maturity. While tree cover can have a beneficial effect upon earthworks, there may be some danger from wind throw - it was also noted that some trees had fallen close to the pound. There is also considerable scrub and bracken growth across the pound – root damage from species, in particular bracken, can have a detrimental effect on buried archaeological remains as well mask earthworks from view.
